# Asland Walks Energy Park

## Assessment report on an Archaeological Evaluation

| <b>Report number date</b> | YA/2025/213 30/09/2025 |

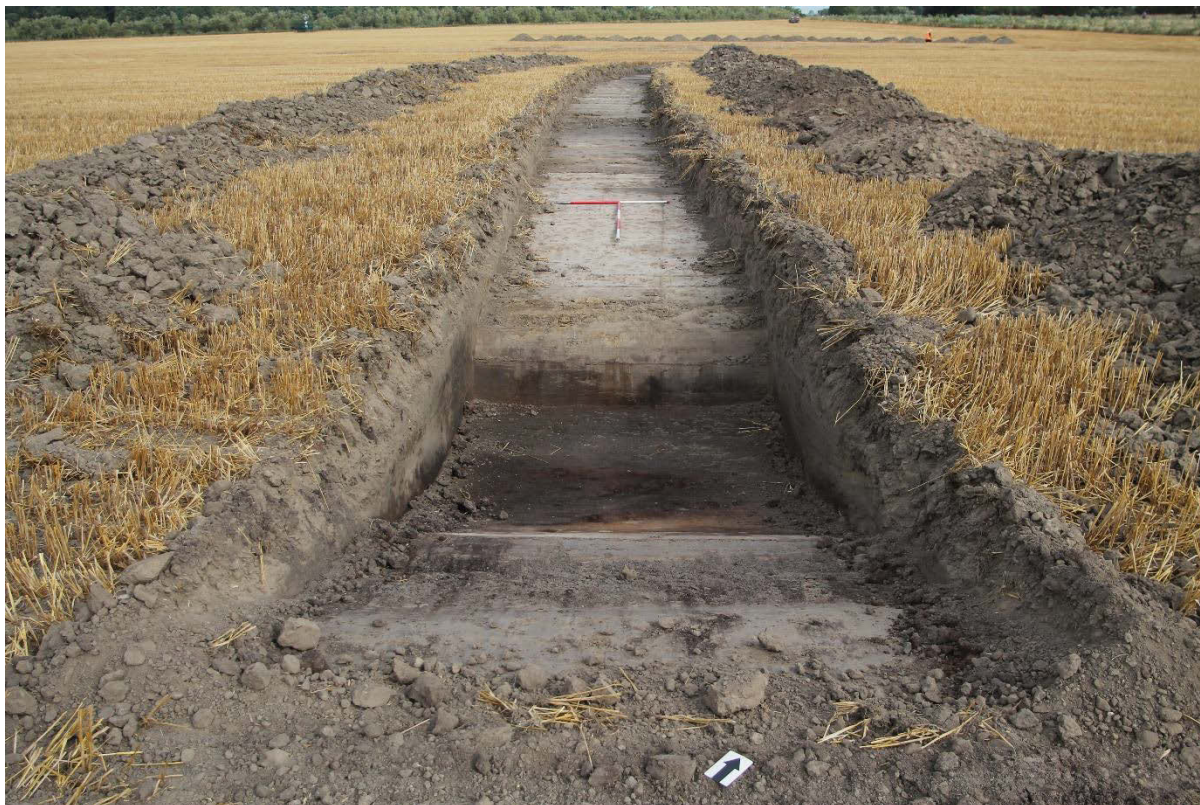
Plate 3: Trench 2, looking northwest. 0.5m scale units.

- 4.2.4 A spongy dark organic/alluvial layer (202) was observed to overlay the natural superficial tidal flat deposits (203) (Plate 3). The natural sands (202) were identified at a depth of 0.95m BGL. A sondage was excavated in the southern end of Trench 2 to a depth of 1.3m BGL and the natural geology was observed to contain a large volume of manganese inclusions (Plate 3).

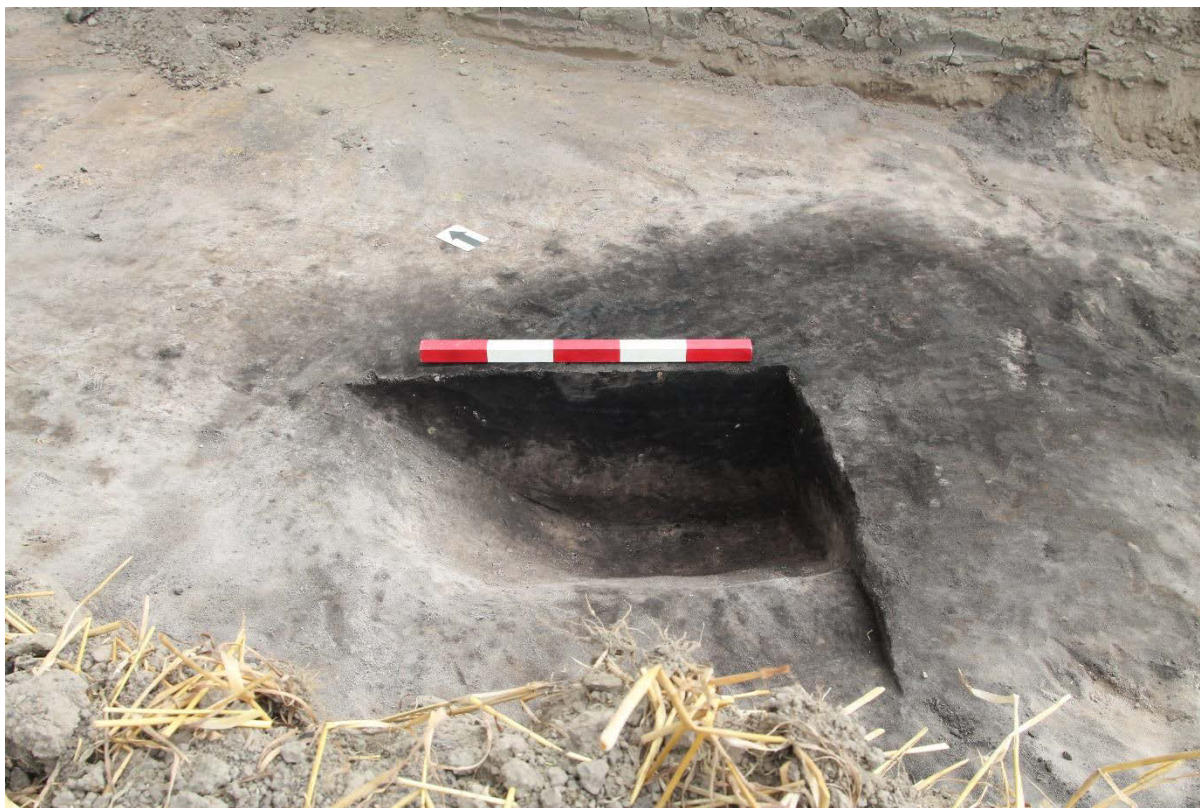
Plate 4: Hedgerow [204], post-ex, looking northeast. 0.10m scale units.

- 4.2.3 The only archaeological feature observed in trench 2 was a linear feature [204], aligned northwest-southeast and terminating in the centre of the trench (Plate 4). Due to the shape, alignment and diffuse edges likely caused by rooting this was interpreted as a hedgerow.

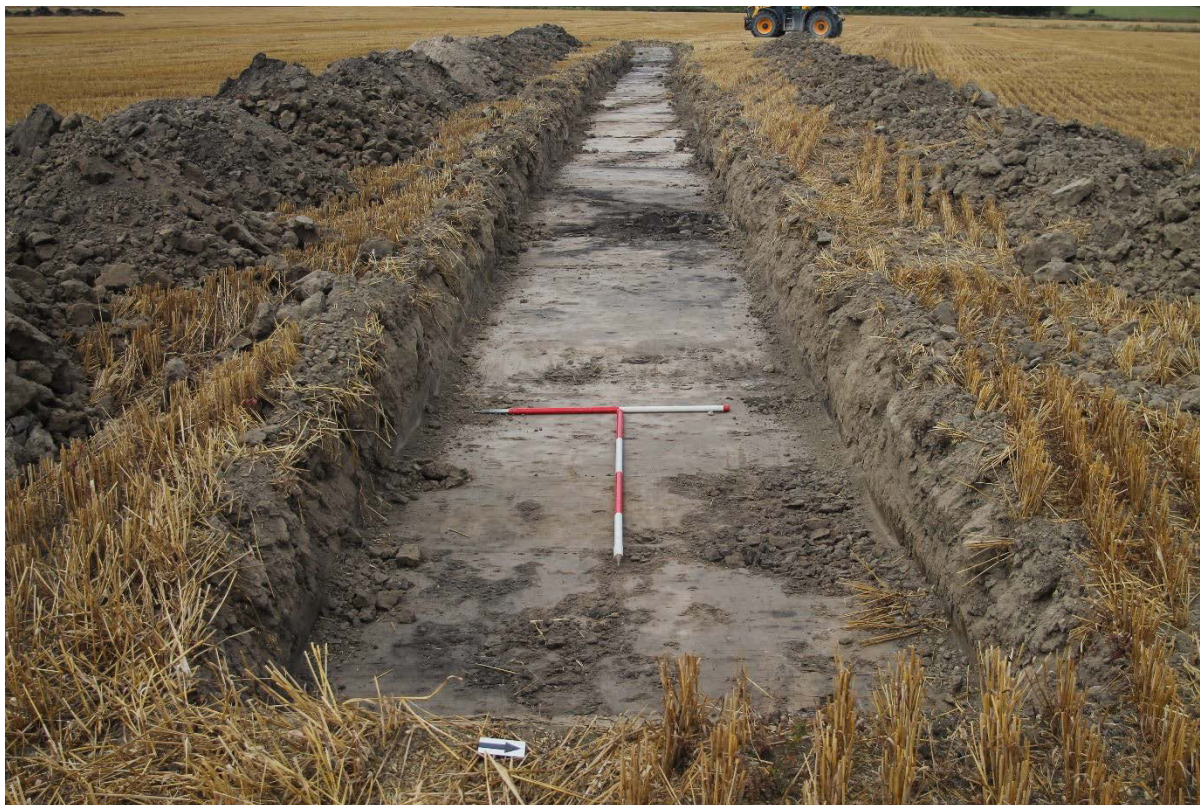
Plate 5: Trench 3, looking west. 0.5m scale units.

- 4.3.1 Trench 3 was located towards the northern side of site (Figure 2). The excavation in trench 3 reached a depth of 0.56m BGL.
- 4.3.2 Trench 3 contained three field drains aligned northwest-southeast and across the southern half of the trench.
- 4.3.3 No archaeological features were observed in this trench and the natural sands (202) were observed at 0.56m BGL (Plate 5; Table 4).

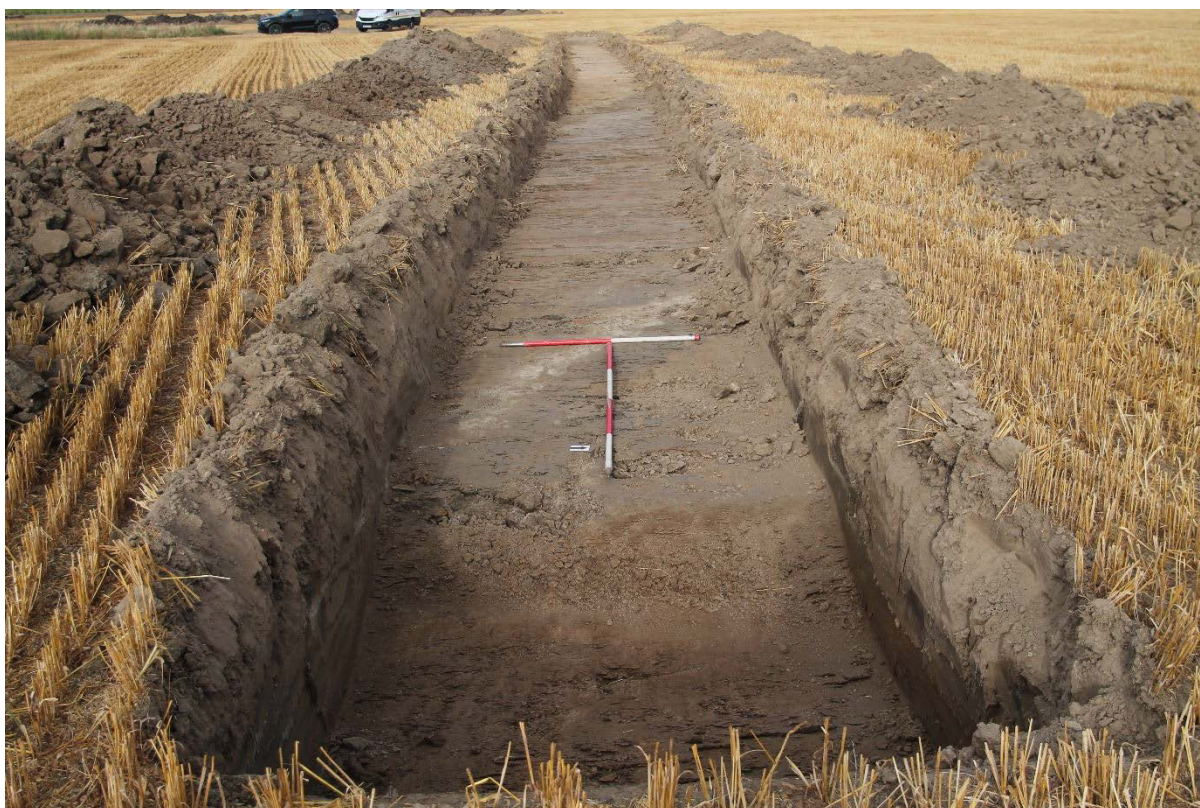
Plate 8: Trench 6, looking west. 0.5m scale units.

- 4.6.1 Trench 6 was located centrally and towards the eastern boundary of site (Figure 2). The excavation in trench 6 reached a depth of 0.48m-1.00m BGL.
- 4.6.2 One field drain was observed in trench 6, aligned northwest-southeast and crossing through the eastern half of the trench.
- 4.6.3 An alluvial silty organic layer (603) was observed to overlay the natural sands (602) in the eastern half of trench 6 extending 30m to the west (Plate 8). In order to ascertain the thickness of this deposit a machine sondage was excavated in the eastern end of the trench to a depth of 1.0m BGL, but the natural sands (602) could not be observed before a safe working depth was exceeded (Plate 8).

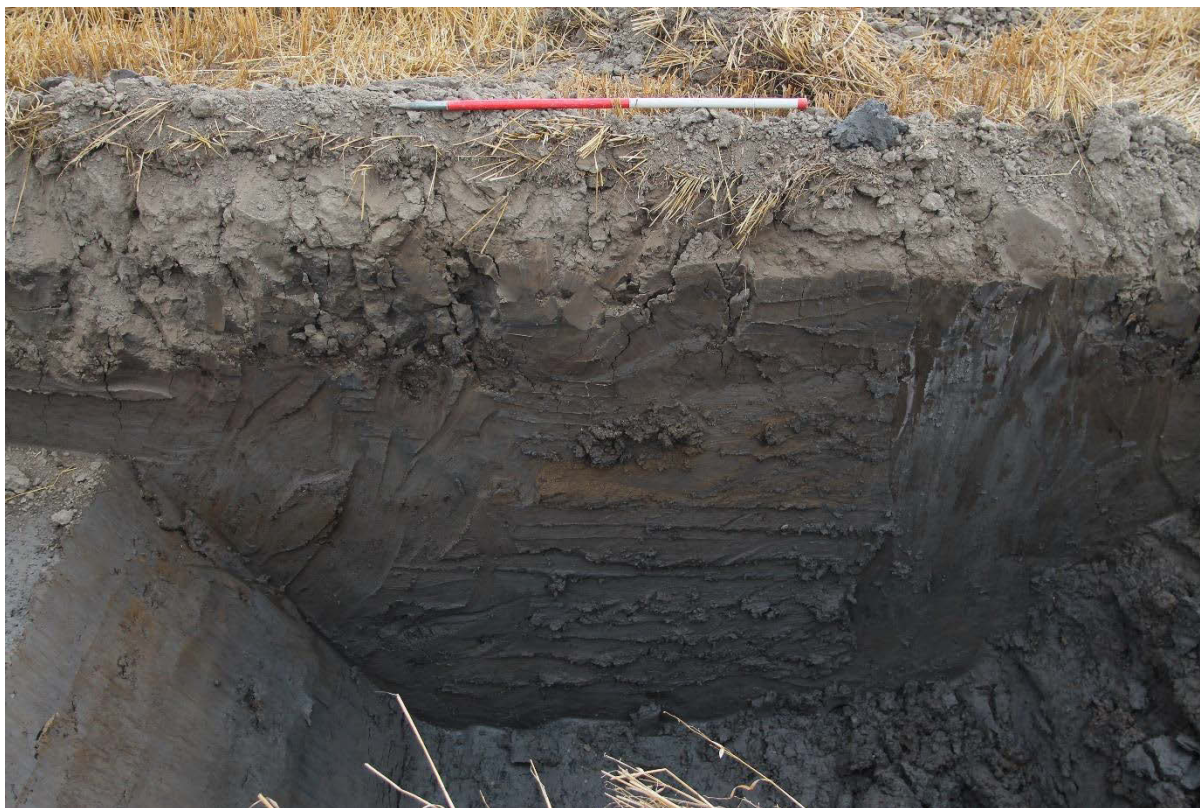
Plate 10: Sondage in southern end of Trench 7 through (701), looking northeast. 0.5m scale units.

- 4.7.1 Trench 7 was located in the centre of site (Figure 2). The excavation in trench 7 reached an average depth of 1.20m BGL, with a sondage at the southern end of the trench reaching depths of approximately 2.50m BGL.
- 4.7.2 Three parallel field drains were observed in the southern half of trench 7 and aligned northwest-southeast
- 4.7.3 No subsoil or archaeological features were observed in trench 7. Beneath the topsoil (700) an organic layer (701) was exposed covering the entire base of the trench (Plate 9). To determine the thickness (701) a sondage was excavated by machine in the southern end of the trench to a depth of approximately 2.50m (Plate 10). Unfortunately, the natural superficial tidal flat sand deposits were not observed at this depth.

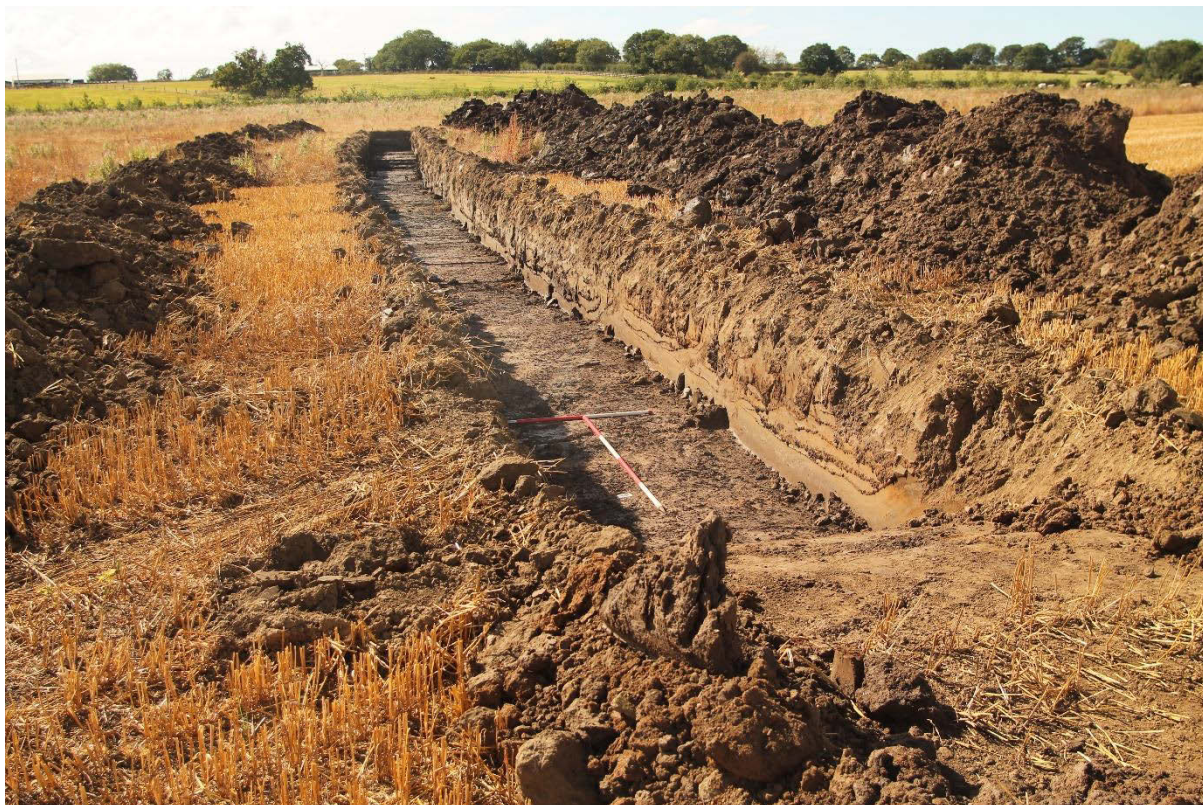
Plate 13: Trench 10, looking northwest. 0.5m scale units.

- 4.10.3 No archaeological features were observed in trench 10. Subsoil was not clear below the topsoil (1000) in this area and instead immediately below the topsoil was an alluvial deposit (1001) which extended beyond the safe working depths of 1.2m BGL. Natural geology was not encountered in this trench.
