Asland Walks Energy Park

Route Survey Report 784-B069995

GA Pet Foods Partners

November 2025

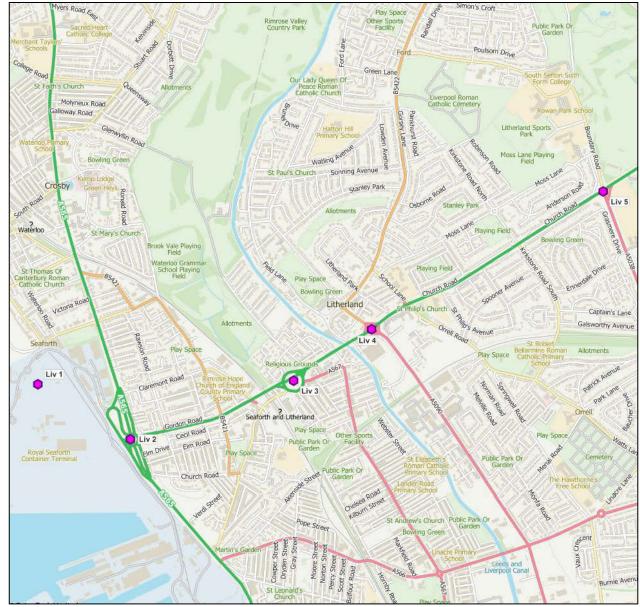
Figure 2.1 - POI Route - Liverpool to Motorway

2.1 The study area, which comprises the POI routes between Royal Seaforth Docks in Liverpool and Switch Island (Western Terminus of M57 and M58) and between M6 Junction 29 and the abnormal loads access with the A50, is illustrated in **Figures 2.1** and **2.2** and also provided at **Appendix A**.

3.1 The preferred delivery route starts at the Port of Entry at Royal Seaforth Docks in Liverpool and extends to the Energy Park via the A565, A5036, motorway network, A6, A582 and the A59. The assessment route is illustrated in **Figures 2.1** and **2.2**.

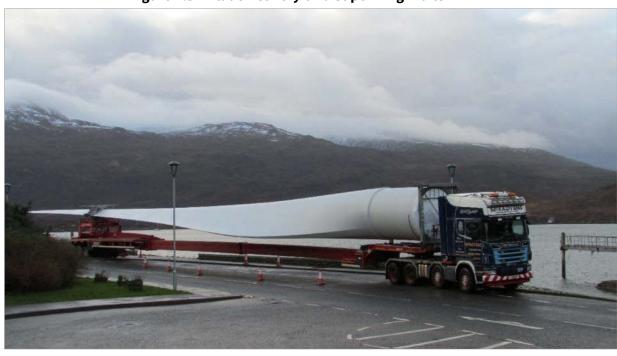
Figure 2.3 - Blade Delivery on a Superwing Trailer

- 2.3 The Superwing trailer allows the load overhang at the rear of the trailer to be adjusted when loaded, by use of a sliding bolster and load rack, and can utilise rear-wheel steering. The components can be delivered on a variety of transport platforms all of which feature independent rear wheel steering and would be provided with both Police and civilian escorts. At this point in time, no assessment of the erection crane has been undertaken.
- 2.4 Figures 2.3 and 2.4 illustrate the delivery of similarly sized components.

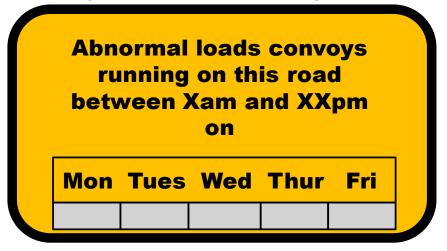
Figure 4.1 - Indicative Information Sign

4.2 Advance warning signs would be installed on the approaches to the affected roads network. Temporary signage advising drivers that abnormal loads will be operating could be erected on the sections of the selected route. Signs such as the example shown in **Figure 4.1** and **4.2** could be installed to help assist drivers. Flip up panels (shown in grey) can be used to mask over days where convoys would not be operating. **Figure 4.2** illustrates a cover panel secured by clips that would alert drivers that no convoys were operating during that week.

4.3 The purpose of this type of signage is to help improve driver information and allow drivers of oncoming traffic to be aware of the potential for wide loads.
